Manhole Inspection Summary

Manhole # S53C__006MH

Insp Date: **6/20/08 8:15 AM**

Location Address: **2 n highland ave**

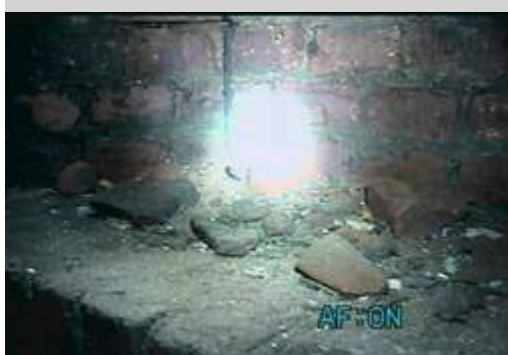
Miscellaneous

bench debris

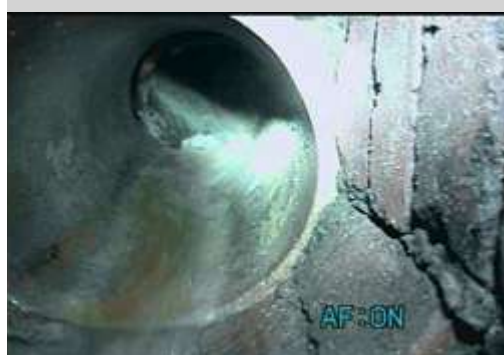
Miscellaneous

inside of 6 looks like there is a hole with soil visiable.

Infiltration: **Evidence** Pipe Seal Cond: **Broken**

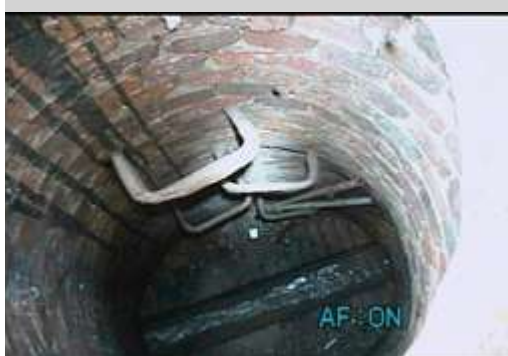
Defect 2

Steps Count: **5** Missing: **1** ☒ **Corroded**

steps

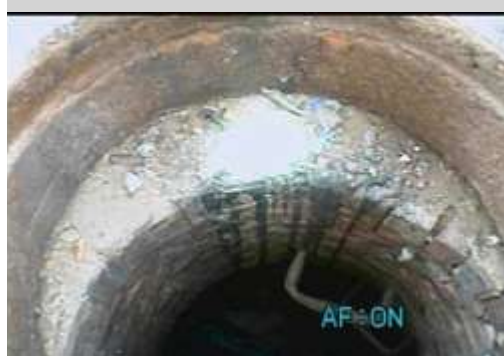
Defect 1

Frame Offset: **6** (in.) Condition: ☒ Sound ☐ Cracked ☐ Leaks

offset

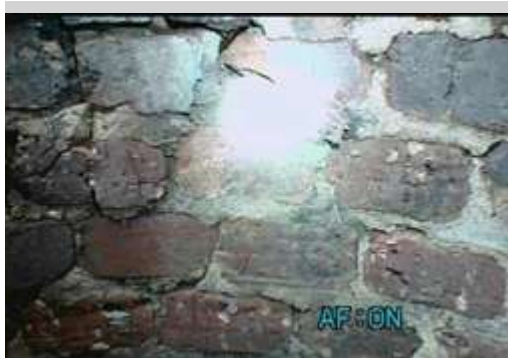
Defect 4

Condition: ☐ Sound ☒ **Cracked** ☐ Root Intrusion ☐ Loose Brick ☐ Deteriorated

corbel cracked

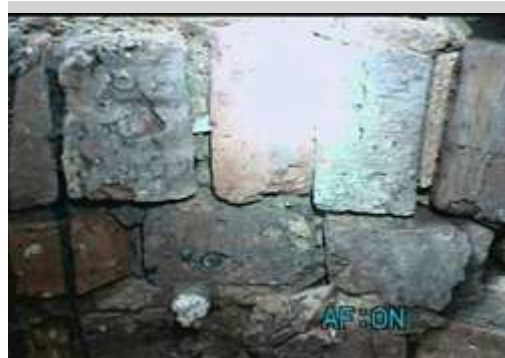
Defect 3

Condition: ☐ Sound ☐ Cracked ☐ Root Intrusion ☒ **Loose Brick** ☐ Deteriorated

chimney loose bricks, frame adj
